**Flood Control Project Maintenance
Levee Inspections**

Maintenance Issue Types Only, Levee Inspection Report By Mile - Fall 2019

Reclamation District No. 0010 Honcut

Waterway	Bank	Unit Miles	Inspection Start/End	Inspector
Unit No. 01 Simmerly Slough	Right	7.65	11/19/2019 11/19/2019	Sterling York

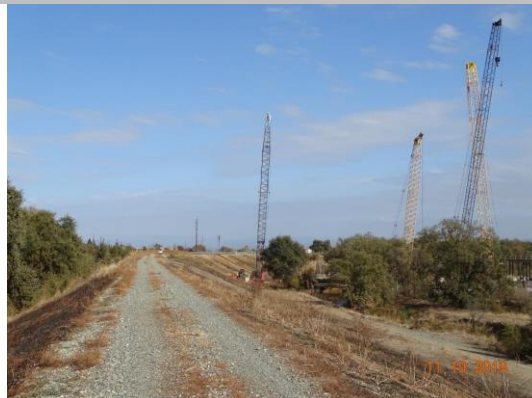
Photo 2 of 2 : FA_2019_RD0010_163_28_20191119_00083.jpg

LM Start	1.28	Rating **	A	Issue No.	28 (cont)	
LM End	1.42	Issue Type +	Ma	Location *	CR	
Category	Earthen Levee			GPS Latitude/Longitude		
				Start		End
Item	Crown Surface / Depressions / Rutting			39.168075 °		39.169123 °
				-121.591579 °		-121.589389 °
DWR ID	DWR_RD0010_01_f_2019_28					
Comment Code						
Inspector Comment						
Construction of the new Highway 70 Bridge, this section is not inspected this fall, Fall 2019.

View looking upstream of the construction of the new Highway 70 Bridge, Fall 2019.

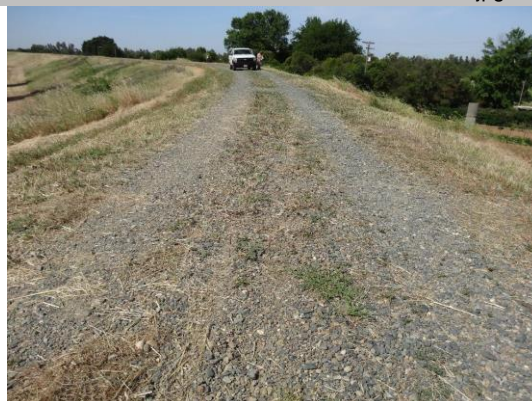
Photo 1 of 3 : UCIP_FA_2019_24811_44582.jpg

Comment Code						
Inspector Comment						
DS_ID:21264 FS_ID:24811 EP_NO: N/A Repair Type: No Action Needed Crossing Status: Found UCIP Comments: 04/29/2013 This crossing is referenced in the USACE Periodic Inspection as item USACE_CESPK_HON1_2013_p_0004. (DWR UCIP - O. Magana) FIELD_STRUCT_DESC: [Reclamation District No. 10 (RD0010) Drainage Plant] 16-inch steel drainage discharge pipe through the levee, 7 feet below the crown. Steel cutoff plate around the pipe at the center of the levee. Siphon breaker on the landside (LS) slope. Flap gate on the waterside (WS) end. Pump in a pit at the LS toe with steps along the LS slope. Saddle and 8-foot splash apron at the discharge end of the pipe. Concrete headwall at the LS toe. Metal shed on the LS slope. [Additional Reference(s): DWR Levee Log, 2005. USACE Sacramento O&M Manual 151, May 1953, (Station 13+88)]. FS Date: 4/29/2013

View of levee crown looking upstream of crossing.

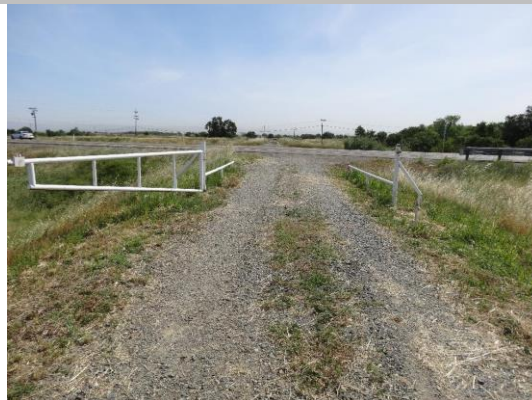
Photo 2 of 3 : UCIP_FA_2019_24811_44581.jpg

View of levee crown looking downstream--access gate near HWY 70.

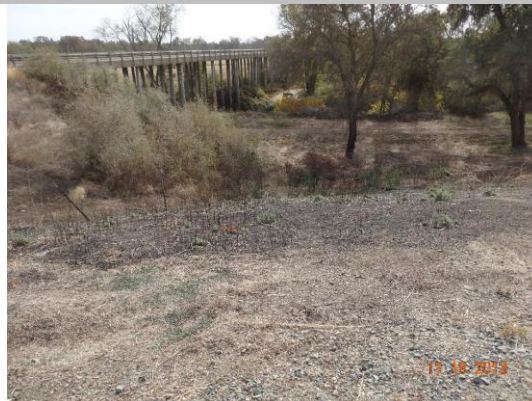
Photo 3 of 3 : UCIP_FA_2019_24811_44585.jpg

View of waterward side.

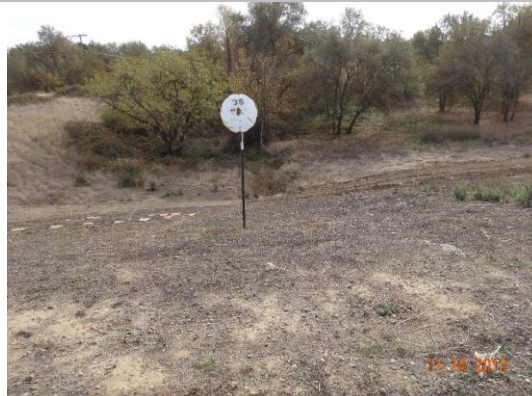
Photo 1 of 3 : UCIP_FA_2019_53136_44588.jpg

DS_ID:21318
FS_ID:53136
EP_NO: N/A
Repair Type: Urgent
Crossing Status: Found
UCIP Comments: 10/18/2018 No change since the last inspection. Pipe remains Urgent due to deteriorated wall (visible holes present inside) near WS flap gate. This pipe is part of DWR's Deferred Maintenance Project (DMP). According to LMA representative, the video inspection of DMP pipes is expected to be completed next year. Levee height is about 25-30 feet. (O. Magana - DWR UCIP)7/01/2016 Pipe wall in poor condition--deteriorated pipe wall indicated by holes at the inlet and outlet pipe collar. Recommend internal integrity inspection of the pipe through the levee to determine extent of damage. (DWR UCIP - omagana)4/29/2013 Holes present on pipe wall. Need to contact owner to notify of issue with pipe. Also need to contact DWR Inspector and CVFPB to determine how to address issue. This crossing is referenced in the USACE Periodic Inspection as item USACE_CESPK_HON1_2013_p_0140. Pipe should be 30-inch instead of 36-inch mentioned Periodic Inspection. (DWR UCIP - omagana) FIELD_STRUCT_DESC: 30-inch corrugated metal gravity drainage pipe through the levee, approximately 30 feet below the crown. Two corrugated metal cutoff walls around the pipe on each side. Saddle and splash apron at the waterside (WS) discharge point. Concrete headwall and sluice gate on the landside (LS). [Additional Reference(s): DWR Levee Log, 2005. USACE Sacramento O&M Manual 151, May 1953, (Station 10+38)].

View of WS--marker present on WS shoulder.

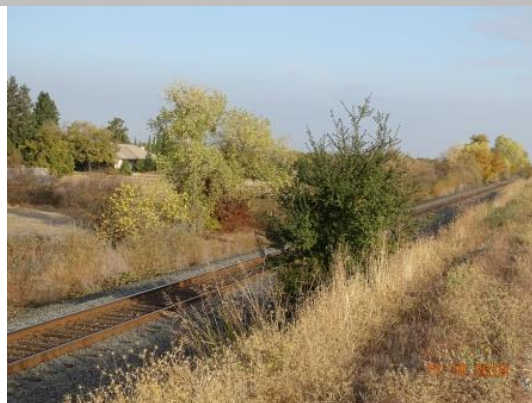
Photo 1 of 1 : FA_2019_RD0010_163_36_20191119_00085.jpg

LM Start	2.79	Rating **	M	Issue No.	36
LM End	2.79	Issue Type +	Ma	Location *	LS
Category	Earthen Levee			GPS Latitude/Longitude	
				Start	End
Item	Trim / Thin Trees			39.186285 °	39.186285 °
				-121.583707 °	-121.583707 °
DWR ID	DWR_RD0010_01_f_2019_36				
Comment Code					
T2 : Thin trees to allow visibility of the ground and room to flood fight.					
Inspector Comment					
Small starter trees on levee slope need to be removed, Fall 2019.

View looking upstream landside at small starter trees that need to be removed, Fall 2019.

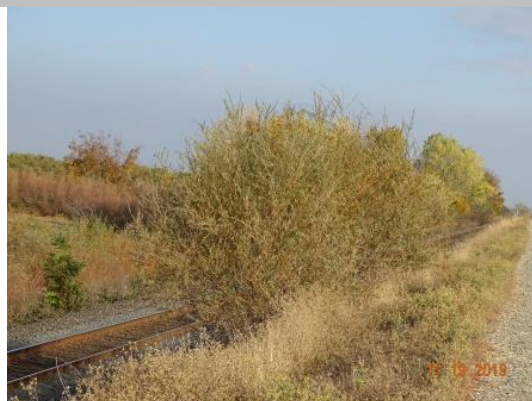
Photo 1 of 1 : FA_2019_RD0010_163_38_20191119_00086.jpg

LM Start	2.92	Rating **	M	Issue No.	38
LM End	2.92	Issue Type +	Ma	Location *	LS
Category	Earthen Levee			GPS Latitude/Longitude	
				Start	End
Item	Trim / Thin Trees			39.188073 °	39.188073 °
				-121.583483 °	-121.583483 °
DWR ID	DWR_RD0010_01_f_2019_38				
Comment Code					
T2 : Thin trees to allow visibility of the ground and room to flood fight.					
Inspector Comment					
Small starter trees on levee slope need to be removed, Fall 2019.

View looking upstream landside at small starter trees that need to be removed, Fall 2019.

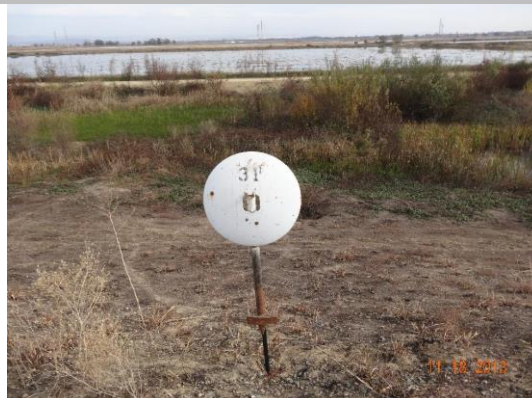
Photo 1 of 3 : UCIP_FA_2019_27746_51436.jpg

Comment Code						
Inspector Comment						
DS_ID:21273						
FS_ID:27746						
EP_NO: N/A						
Repair Type: No Action Needed						
Crossing Status: Found						
UCIP Comments: 04/29/2013 This crossing is referenced in the						
USACE Periodic Inspection as item						
USACE_CESPK_HON1_2013_p_0217. (DWR UCIP - O. Magana)						
FIELD_STRUCT_DESC: 24-inch reinforced concrete gravity drainage						
pipe through the levee, 19.5 feet below the crown. Flap gate on the						
waterside (WS) end. Concrete headwall at each toe. Concrete saddle						
and apron on the WS. [Additional Reference(s): DWR Levee Log, 2005.						
USACE Sacramento O&M Manual 151, May 1953, (Station 317+80)].						
FS Date: 4/29/2013

View of waterward side--marker for pipe visible on waterward shoulder.

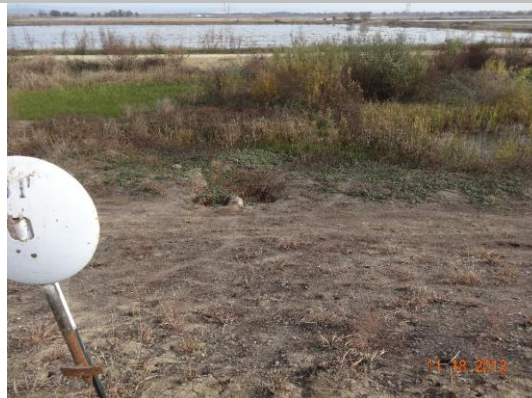
Photo 2 of 3 : UCIP_FA_2019_27746_51435.jpg

View of pipe on waterward toe.

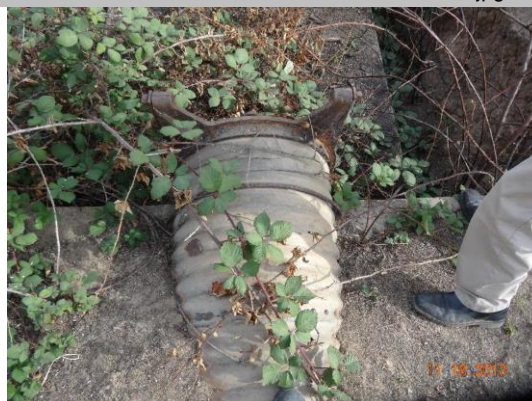
Photo 3 of 3 : UCIP_FA_2019_27746_51439.jpg

Comment Code						
Inspector Comment						
DS_ID:21273 FS_ID:27746 EP_NO: N/A Repair Type: No Action Needed Crossing Status: Found UCIP Comments: 04/29/2013 This crossing is referenced in the USACE Periodic Inspection as item USACE_CESPK_HON1_2013_p_0217. (DWR UCIP - O. Magana) FIELD_STRUCT_DESC: 24-inch reinforced concrete gravity drainage pipe through the levee, 19.5 feet below the crown. Flap gate on the waterside (WS) end. Concrete headwall at each toe. Concrete saddle and apron on the WS. [Additional Reference(s): DWR Levee Log, 2005. USACE Sacramento O&M Manual 151, May 1953, (Station 317+80)]. FS Date: 4/29/2013

View of pipe, headwall, and concrete apron on waterward toe.

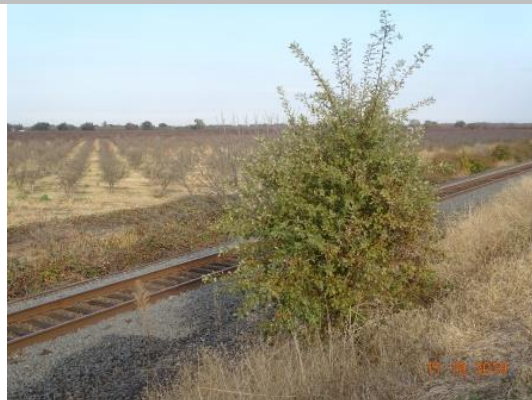
Photo 1 of 1 : FA_2019_RD0010_163_39_20191119_00087.jpg

LM Start	4.63	Rating **	M	Issue No.	39
LM End	4.63	Issue Type +	Ma	Location *	LS
Category	Earthen Levee			GPS Latitude/Longitude	
				Start	End
Item	Trim / Thin Trees			39.212749 °	39.212749 °
				-121.580406 °	-121.580406 °
DWR ID	DWR_RD0010_01_f_2019_39				
Comment Code					
T2 : Thin trees to allow visibility of the ground and room to flood fight.					
Inspector Comment					
Small starter trees on levee slope need to be removed, Fall 2019.

View looking upstream landside at small starter trees that need to be removed, Fall 2019.

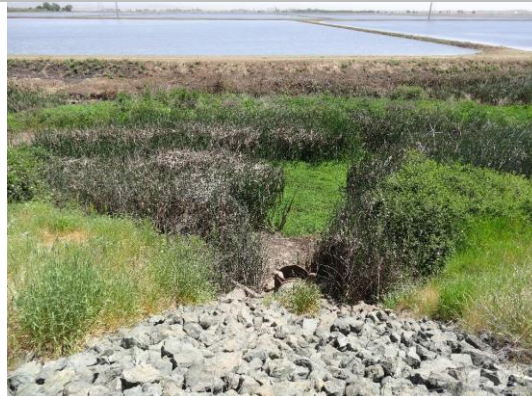
Photo 2 of 3 : UCIP_FA_2019_53138_44809.jpg

Comment Code						
Inspector Comment						
DS_ID:21275 FS_ID:53138 EP_NO: N/A Repair Type: Urgent Crossing Status: Found UCIP Comments: 10/18/2018 According to the LMA representative, a small pipe repair was completed near the WS gate (pipe was leaking at pipe collar). Pipe has been upgraded from Non-Urgent to Urgent due to the wall deterioration near the outlet and an unknown condition through the levee. Levee is about 20 feet high. Recommend video inspection to determine pipe condition through the levee. This pipe is part of DWR's Deferred Maintenance Project (DMP), video inspection is expected to be completed next year for this crossing. (O. Magana - DWR UCIP)7/01/2016 WS slope appears to be stable; UCIP issue has been downgraded from Urgent to Non-Urgent due to what appears to be a stable slope--no other issues were observed during the site visit. The reason for the Non-Urgent classification is due to the limited documentation available to support extent of repair--need to obtain repair records to determine extent of repair and to determine if pipe was replaced through the levee. (DWR UCIP - omagana)4/29/2013 limited access; steep slopes, and dense vegetation; New riprap has been placed along pipe alignment need to contact owner to determine work authorization. Also need to find out if the design for riprap was due to slope failure at this location. This crossing is referenced in the USACE Periodic Inspection as item USACE_CESPK_HON1_2013_p_0246. (DWR UCIP - omagana) FIELD_STRUCT_DESC: 36-inch corrugated metal gravity drainage pipe through the levee, 20 feet below the crown. Two corrugated metal cutoff walls around the pipe on each shoulder. Flap gate on the waterside (WS) end. Concrete headwall on the WS toe. Grouted cobble headwall on the landside (LS) toe. Concrete saddle and apron on the WS. [Additional Reference(s): DWR Levee Log, 2005. USACE Sacramento O&M Manual 151, May 1953, (Station 381+76.24)]. FS Date: 10/18/2018

View of WS during April.

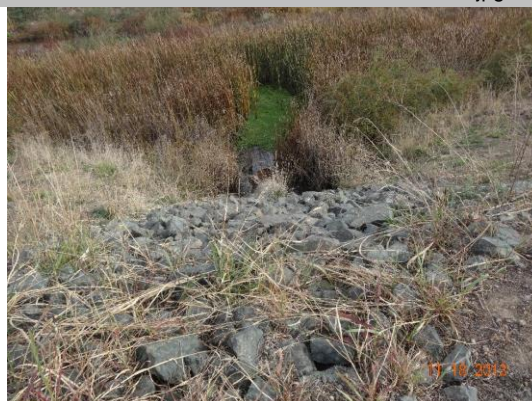
Photo 3 of 3 : UCIP_FA_2019_53138_44810.jpg

View of WS slope covered with rip rap along pipe alignment.

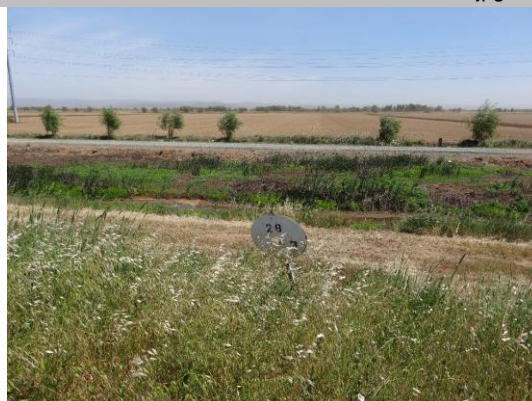
Photo 1 of 3 : UCIP_FA_2019_24438_43503.jpg

Comment Code					
Inspector Comment					
DS_ID:21278 FS_ID:24438 EP_NO: N/A Repair Type: Non-Urgent Crossing Status: Found UCIP Comments: 04/29/2013 Dense vegetation limits the inspector's visibility to identify signs of pipe failure (leaks) along the slope. Recommend removing vegetation along pipe alignment to conduct proper inspection of structure and appurtances. This crossing is referenced in the USACE Periodic Inspection as item USACE_CESPK_HON1_2013_p_0290. (DWR UCIP - O. Magana) FIELD_STRUCT_DESC: 30-inch corrugated metal gravity drainage pipe through the levee, 12.5 feet below the crown. Corrugated metal cutoff wall around the pipe at each shoulder. Flap gate on the waterside (WS) end. Concrete headwall, saddle, and apron on the WS end. [Additional Reference(s): DWR Levee Log, 2005. USACE Sacramento O&M Manual 151, May 1953, (Station 455+00)]. FS Date: 4/29/2013

Marker visible on waterward shoulder.

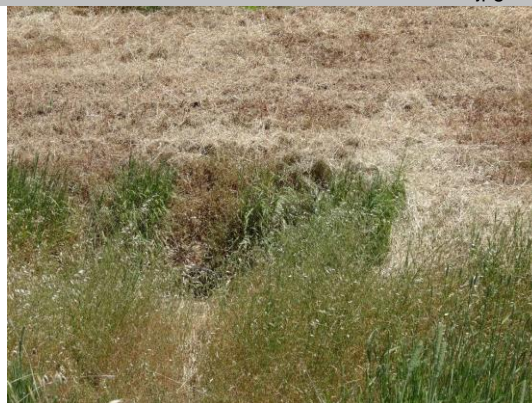
Photo 2 of 3 : UCIP_FA_2019_24438_43502.jpg

View of waterward toe where pipe daylighting.

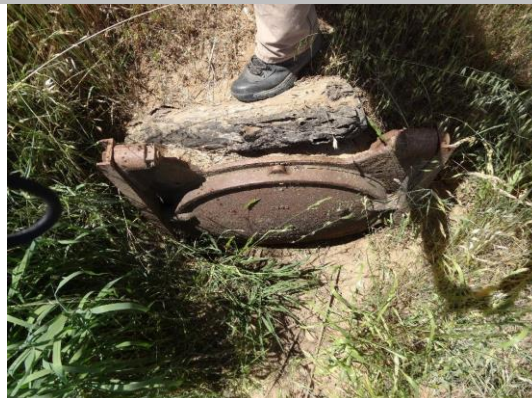
Photo 3 of 3 : UCIP_FA_2019_24438_43501.jpg

Comment Code						
Inspector Comment						
DS_ID:21278 FS_ID:24438 EP_NO: N/A Repair Type: Non-Urgent Crossing Status: Found UCIP Comments: 04/29/2013 Dense vegetation limits the inspector's visibility to identify signs of pipe failure (leaks) along the slope. Recommend removing vegetation along pipe alignment to conduct proper inspection of structure and appurtances. This crossing is referenced in the USACE Periodic Inspection as item USACE_CESPK_HON1_2013_p_0290. (DWR UCIP - O. Magana) FIELD_STRUCT_DESC: 30-inch corrugated metal gravity drainage pipe through the levee, 12.5 feet below the crown. Corrugated metal cutoff wall around the pipe at each shoulder. Flap gate on the waterside (WS) end. Concrete headwall, saddle, and apron on the WS end. [Additional Reference(s): DWR Levee Log, 2005. USACE Sacramento O&M Manual 151, May 1953, (Station 455+00)]. FS Date: 4/29/2013

Pipe and flap gate confirmed on waterward side.

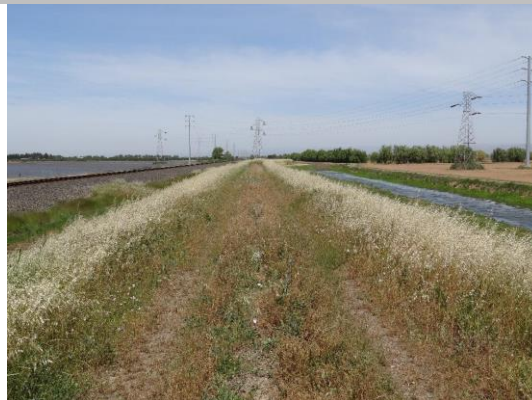
Photo 1 of 3 : UCIP_FA_2019_27532_51129.jpg

View of levee looking upstream.

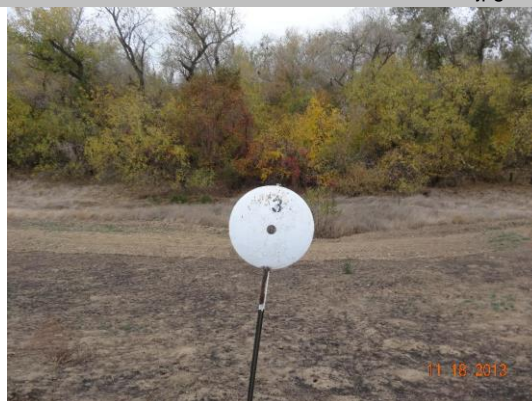
Photo 1 of 3 : UCIP_FA_2019_27533_51135.jpg

View of waterward side.

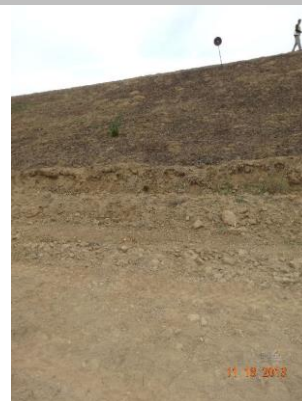
Photo 2 of 3 : UCIP_FA_2019_27533_51137.jpg

Comment Code						
Inspector Comment						
DS_ID:21280 FS_ID:27533 EP_NO: N/A Repair Type: Non-Urgent Crossing Status: Found UCIP Comments: 04/30/2013 Recommend removing vegetation and debris along pipe alignment (debris blocking gate on waterward side and vegetation blocking access to screw gate on landward side). Need to coordinate with owner to determine status of crossing. If crossing is no longer in use owner will need to contact the CVFPB to comply with Title 23. This crossing is referenced in the USACE Periodic Inspection as item USACE_CESPK_HON2_2013_p_0027. (DWR UCIP - O. Magana) FIELD_STRUCT_DESC: 24-inch corrugated metal gravity drainage pipe through the levee, 25.6 feet below the crown. Corrugated metal cutoff wall around the pipe at each shoulder. Flap gate on the waterside (WS) end. Concrete headwall, saddle, and apron on the WS end. [Additional Reference(s): DWR Levee Log, 2005. USACE Sacramento O&M Manual 151, May 1953, (Station 106+00)]. FS Date: 4/30/2013

View of waterward slope.

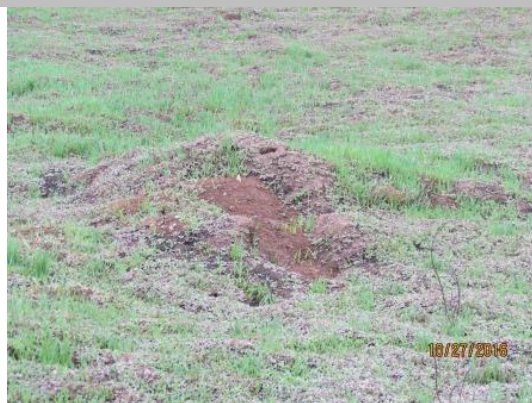
Photo 1 of 1 : FA_2019_RD0010_164_29_20190904_00004.jpg

LM Start	0.94	Rating **	U	Issue No.	29
LM End	0.94	Issue Type +	Ma	Location *	WS
Category	Earthen Levee			GPS Latitude/Longitude	
				Start	End
Item	Animal Control			39.177289 °	39.177289 °
				-121.609860 °	-121.609860 °
DWR ID	DWR_RD0010_02_f_2015_29				
Comment Code					
A3 : No rodents visible, but rodent burrows visible; need to backfill and compact or grout burrows.					
Inspector Comment					
No rodent activity but squirrel hole needs to be backfilled, Fall 2019.

View of rodent hole that has more than 2 cubic feet of material on the waterside.

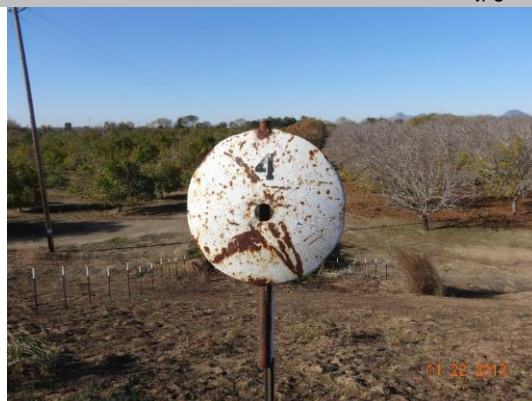
Photo 1 of 3 : UCIP_FA_2019_24821_44640.jpg

Marker visible on waterward side--No. 4.

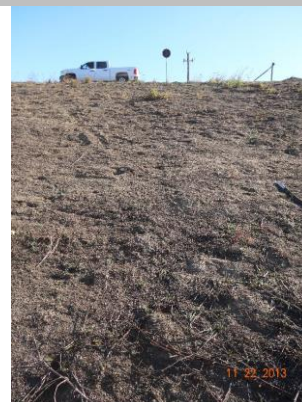
Photo 2 of 3 : UCIP_FA_2019_24821_44639.jpg

View of waterward slope side.

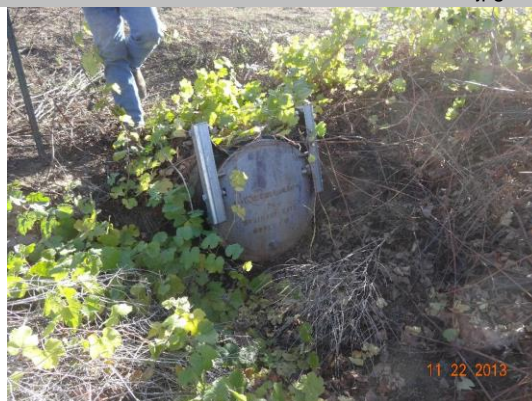
Photo 3 of 3 : UCIP_FA_2019_24821_44638.jpg

Comment Code						
Inspector Comment						
DS_ID:21281						
FS_ID:24821						
EP_NO: N/A						
Repair Type: Non-Urgent						
Crossing Status: Found						
UCIP Comments: 04/30/2013 Screw gate on landward side is blocked by sediment. Recommend removing sediment in front of gate. This crossing is referenced in the USACE Periodic Inspection as item USACE_CESPK_HON2_2013_p_0082. (DWR UCIP - O. Magana)						
FIELD_STRUCT_DESC: 24-inch corrugated metal gravity drainage pipe through the levee, 26 feet below the crown. Corrugated metal cutoff wall around the pipe at each shoulder. Flap gate on the waterside (WS) end. Slide gate on the landside (LS) end. Concrete headwall, saddle, and apron on the WS end. [Additional Reference(s): DWR Levee Log, 2005. USACE Sacramento O&M Manual 151, May 1953, (Station 149+88)].						
FS Date: 4/30/2013

View of flap gate located on waterward side.

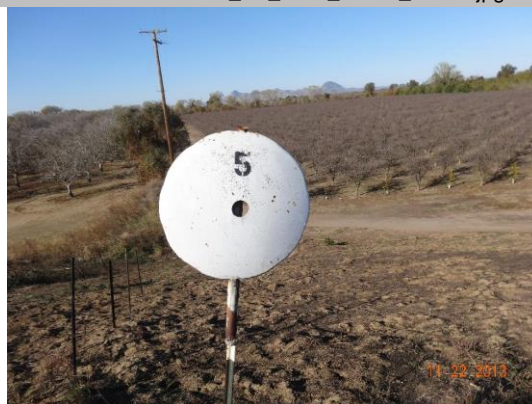
Photo 1 of 3 : UCIP_FA_2019_24822_44647.jpg

Marker visible on waterward side--No. 5.

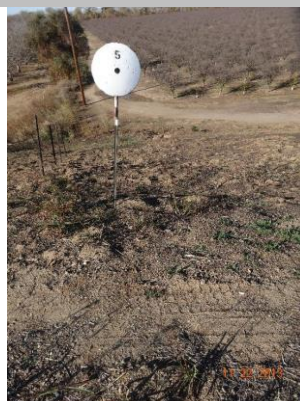
Photo 2 of 3 : UCIP_FA_2019_24822_44648.jpg

Overview of waterward slope--dense burrow activity on slope.

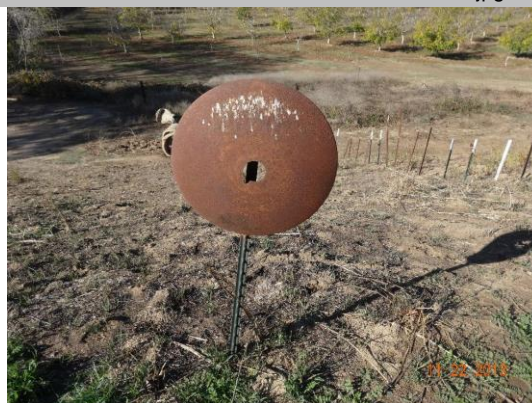
Photo 1 of 3 : UCIP_FA_2019_52889_44658.jpg

Marker visible on waterward side.

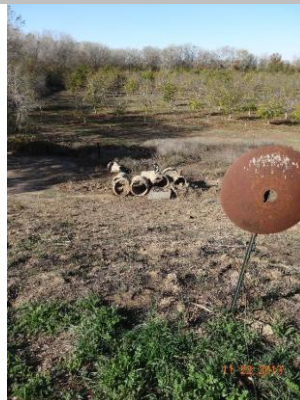
Photo 2 of 3 : UCIP_FA_2019_52889_44657.jpg

Overview of waterward slope--barrier placed at toe to discourage damage to crossing.

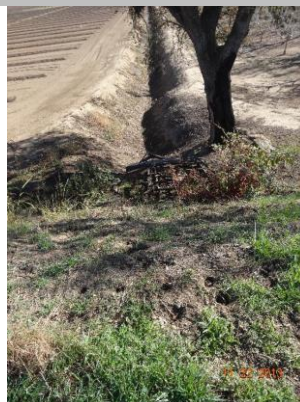
Photo 3 of 3 : UCIP_FA_2019_52889_44656.jpg

Comment Code						
Inspector Comment						
DS_ID:21284						
FS_ID:52889						
EP_NO: N/A						
Repair Type: Non-Urgent						
Crossing Status: Found						
UCIP Comments: 04/30/2013 Remove concrete piece preventing complete closure of screw gate on landward side. This crossing is referenced in the USACE Periodic Inspection as item USACE_CESPK_HON2_2013_p_0152. (DWR UCIP - O. Magana)						
FIELD_STRUCT_DESC: 36-inch corrugated metal gravity drainage pipe through the levee, 24 feet below the crown. Corrugated metal cutoff wall around the pipe at each shoulder. Flap gate on the waterside (WS) end. Slide gate on the landside (LS) end. Concrete headwall at each end.						
[Additional Reference(s): DWR Levee Log, 2005. USACE Sacramento O&M Manual 151, May 1953, (Station 259+76)].						
FS Date: 4/30/2013

View of landward side--barrier used to discourage damage to crossing near toe.

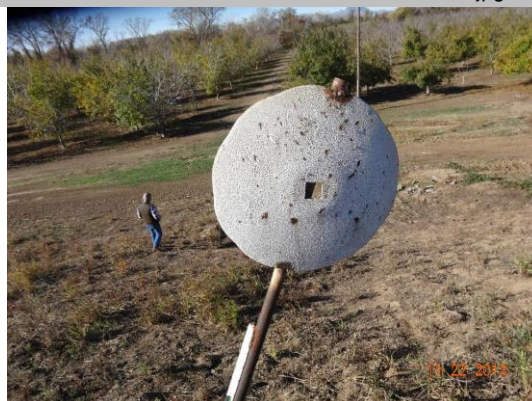
Photo 1 of 3 : UCIP_FA_2019_24825_44664.jpg

Marker visible on waterward side.

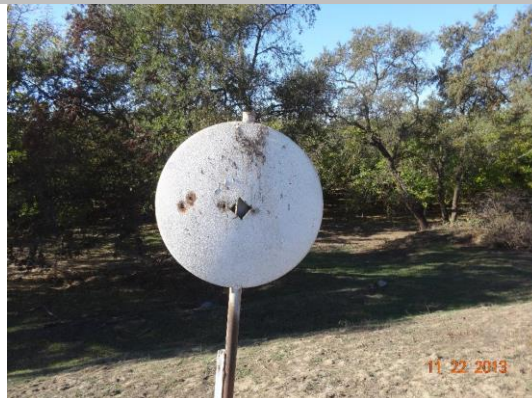
Photo 1 of 3 : UCIP_FA_2019_24826_44669.jpg

View of marker located on waterward shoulder, no reference number is visible.

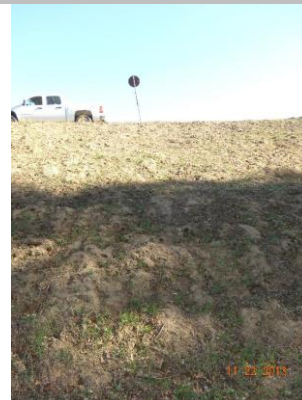
Photo 2 of 3 : UCIP_FA_2019_24826_44668.jpg

View of waterward slope.

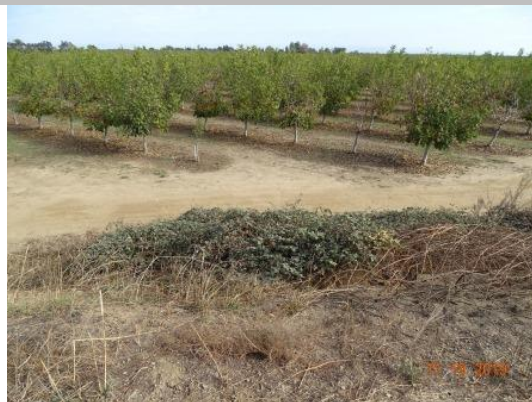
Photo 1 of 1 : FA_2019_RD0010_164_58_20191120_00102.jpg

LM Start	4.17	Rating **	M	Issue No.	58
LM End	4.17	Issue Type +	Ma	Location *	LS
Category	Earthen Levee			GPS Latitude/Longitude	
				Start	End
Item	Vegetation			39.223276 °	39.223276 °
				-121.612510 °	-121.612510 °
DWR ID	DWR_RD0010_02_f_2019_58				
Comment Code					
V2 : Remove the wild growth other than native grasses from the levee slopes.					
Inspector Comment					
Remove blackberry bushes from levee slope, Fall 2019.

View looking at blackberry bushes on the landside levee slope that need to be removed, Fall 2019.

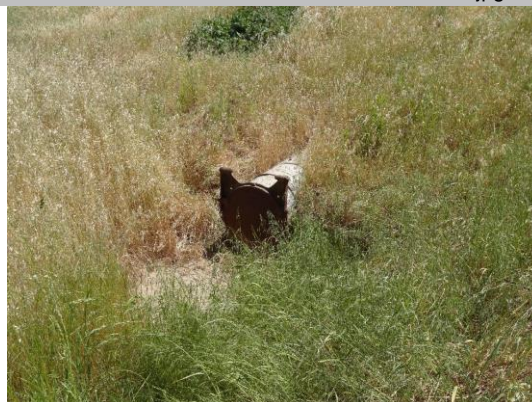
Photo 2 of 3 : UCIP_FA_2019_24751_44376.jpg

View of flap gate on waterward side.

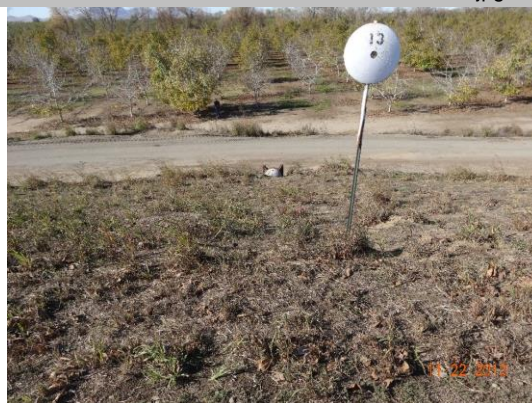
Photo 1 of 3 : UCIP_FA_2019_27793_51514.jpg

Comment Code						
Inspector Comment						
DS_ID:21291						
FS_ID:27793						
EP_NO: N/A						
Repair Type: Non-Urgent						
Crossing Status: Found						
UCIP Comments: 04/30/2013 Need to contact owner to remove debris inside concrete distribution box and on slope. This crossing is referenced in the USACE Periodic Inspection as item USACE_CESPK_HON2_2013_p_0244. (DWR UCIP - O. Magana)						
FIELD_STRUCT_DESC: 30-inch corrugated metal gravity drainage pipe through the levee, 17.3 feet below the crown. Corrugated metal cutoff wall around the pipe at each shoulder. Flap gate on the waterside (WS) end. Slide gate on the landside (LS) end. Concrete headwall at each end. [Additional Reference(s): DWR Levee Log, 2005. USACE Sacramento O&M Manual 151, May 1953, (Station 413+81)].						
FS Date: 4/30/2013

View of marker located on waterward shoulder, pipe is reference as No. 13.

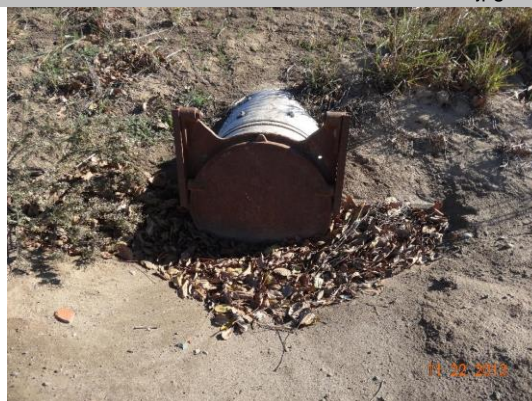
Photo 2 of 3 : UCIP_FA_2019_27793_51517.jpg

View of flap gate located on waterward side.

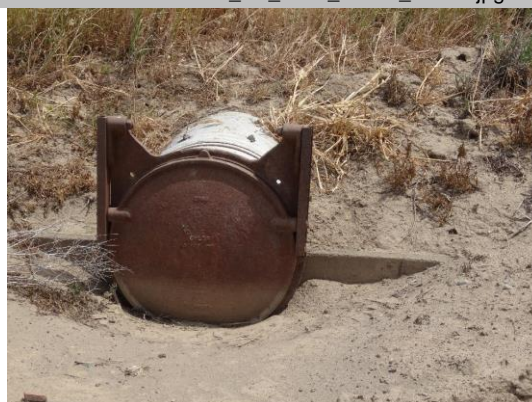
Photo 3 of 3 : UCIP_FA_2019_27793_51513.jpg

Flap gate and concrete headwall visible on waterward side.

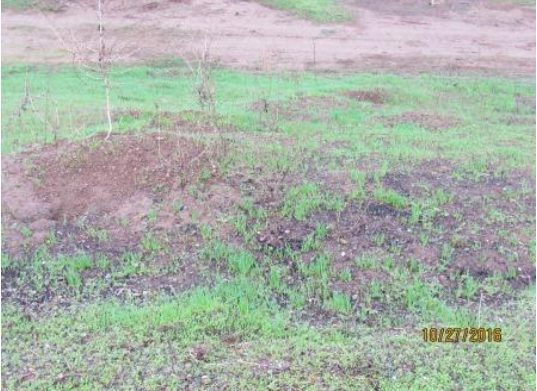
Photo 1 of 1 : FA_2019_RD0010_164_32_20190904_00007.jpg

View of rodent holes on waterside levee slope.

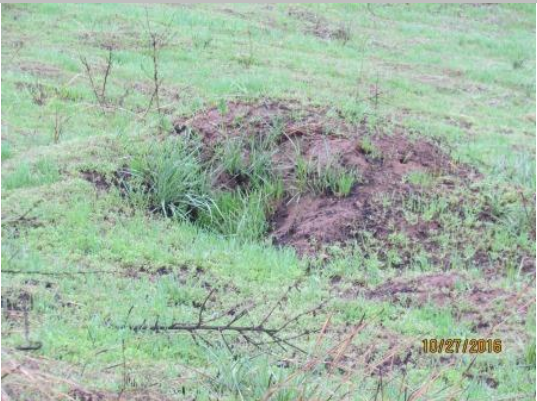
Photo 1 of 1 : FA_2019_RD0010_164_33_20190904_00008.jpg

View of rodent hole that has more than 2 cubic feet of material, this hole is not active but needs to be backfilled properly.

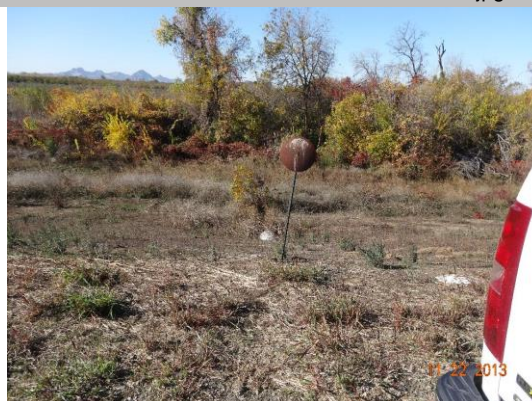
Photo 1 of 3 : UCIP_FA_2019_24831_44700.jpg

Visible marker located on waterward shoulder--no id number noted.

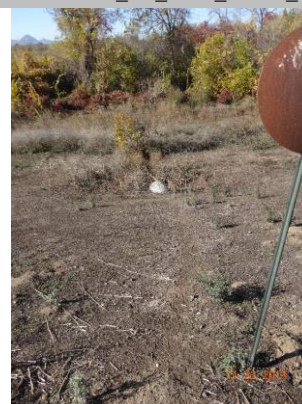
Photo 2 of 3 : UCIP_FA_2019_24831_44699.jpg

View of waterward slope.

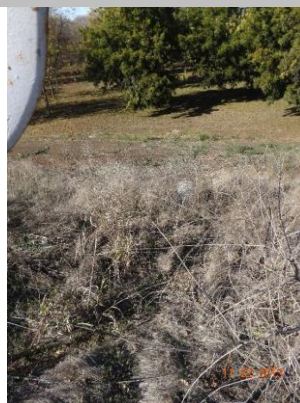
Photo 2 of 3 : UCIP_FA_2019_24832_44704.jpg

View of waterward side.

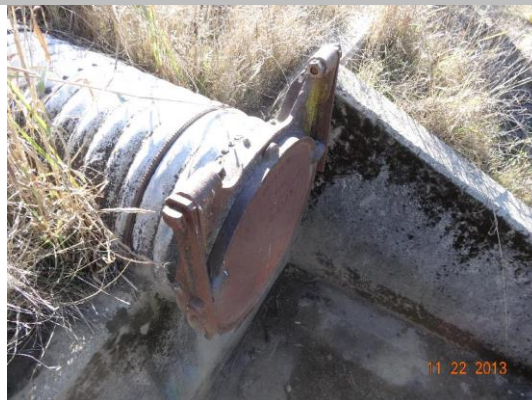
Photo 3 of 3 : UCIP_FA_2019_24832_44703.jpg

View of flap gate located on waterward side.

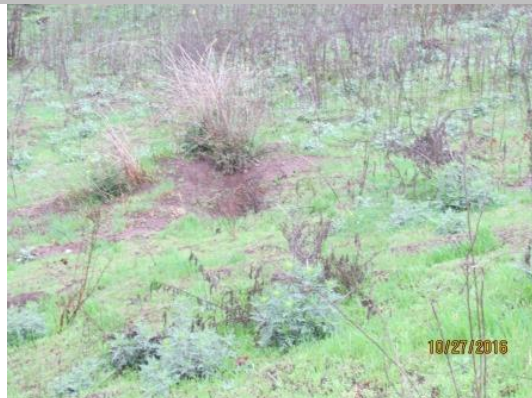
Photo 1 of 1 : FA_2019_RD0010_164_35_20190904_00011.jpg

LM Start	8.09	Rating **	M	Issue No.	35
LM End	8.09	Issue Type +	Ma	Location *	WS
Category	Earthen Levee			GPS Latitude/Longitude	
				Start	End
Item	Animal Control			39.275179 °	39.275179 °
				-121.611283 °	-121.611283 °
DWR ID	DWR_RD0010_02_f_2015_35				
Comment Code					
A3 : No rodents visible, but rodent burrows visible; need to backfill and compact or grout burrows.					
Inspector Comment					
No rodent activity but holes need to be backfilled, Fall 2019.

View of rodent hole on waterside.

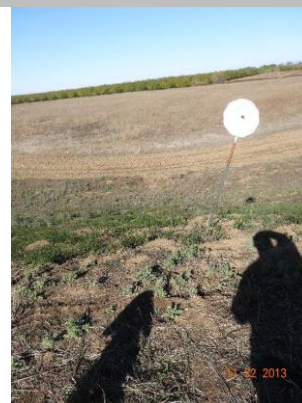
Photo 1 of 3 : UCIP_FA_2019_27775_51473.jpg

Comment Code					
Inspector Comment					
DS_ID:21296 FS_ID:27775 EP_NO: N/A Repair Type: Non-Urgent Crossing Status: Found UCIP Comments: 04/30/2013 Sediment build-up at the inlet--recommend clearing sediment. This crossing is referenced in the USACE Periodic Inspection as item USACE_CESPK_HON2_2013_p_0348. (DWR UCIP - O. Magana) FIELD_STRUCT_DESC: 30-inch corrugated metal gravity drainage pipe through the levee, 23 feet below the crown. Corrugated metal cutoff wall around the pipe at each shoulder. Flap gate on the waterside (WS) end. Slide gate on the landside (LS) end. Concrete headwall at each end. Metal marker on the WS shoulder. [Additional Reference(s): DWR Levee Log, 2005. USACE Sacramento O&M Manual 151, May 1953, (Station 551+96)]. FS Date: 4/30/2013

View of waterward side.

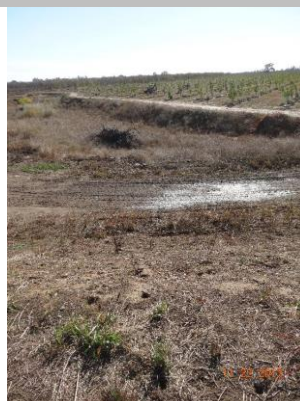
Photo 2 of 3 : UCIP_FA_2019_27775_51472.jpg

Comment Code						
Inspector Comment						
DS_ID:21296 FS_ID:27775 EP_NO: N/A Repair Type: Non-Urgent Crossing Status: Found UCIP Comments: 04/30/2013 Sediment build-up at the inlet--recommend clearing sediment. This crossing is referenced in the USACE Periodic Inspection as item USACE_CESPK_HON2_2013_p_0348. (DWR UCIP - O. Magana) FIELD_STRUCT_DESC: 30-inch corrugated metal gravity drainage pipe through the levee, 23 feet below the crown. Corrugated metal cutoff wall around the pipe at each shoulder. Flap gate on the waterside (WS) end. Slide gate on the landside (LS) end. Concrete headwall at each end. Metal marker on the WS shoulder. [Additional Reference(s): DWR Levee Log, 2005. USACE Sacramento O&M Manual 151, May 1953, (Station 551+96)]. FS Date: 4/30/2013

View of landward side.

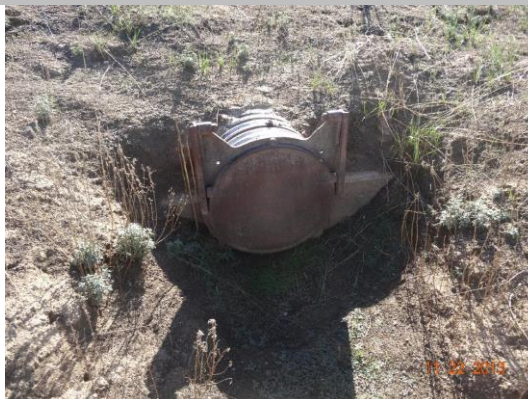
Photo 3 of 3 : UCIP_FA_2019_27775_51477.jpg

View of flap gate visible on waterward side.

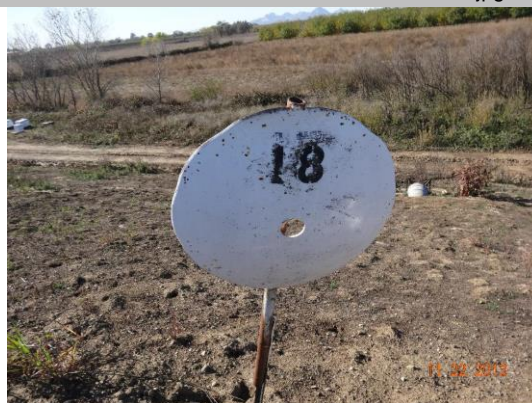
Photo 1 of 3 : UCIP_FA_2019_24834_44715.jpg

Comment Code						
Inspector Comment						
DS_ID:21297 FS_ID:24834 EP_NO: N/A Repair Type: Non-Urgent Crossing Status: Found UCIP Comments: 04/30/2013 Slide gate missing on landward side. Need to contact owner to determine status of crossing. This crossing is referenced in the USACE Periodic Inspection as item USACE_CESPK_HON2_2013_p_0367. (DWR UCIP - O. Magana) FIELD_STRUCT_DESC: 24-inch corrugated metal gravity drainage pipe through the levee, 14 feet below the crown. Corrugated metal cutoff wall around the pipe at each shoulder. Flap gate on the waterside (WS) end. Slide gate on the landside (LS), slide gate missing. Concrete headwall, saddle, and apron on the WS end. 6-foot by 6-foot concrete splash apron at the WS toe. [Additional Reference(s): DWR Levee Log, 2005. USACE Sacramento O&M Manual 151, May 1953, (Station 565+74)]. FS Date: 4/30/2013

Marker visible on waterward shoulder, crossing is referenced as No. 18.

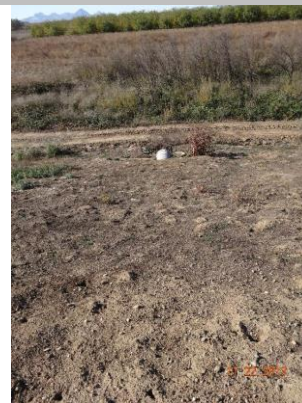
Photo 2 of 3 : UCIP_FA_2019_24834_44714.jpg

View of waterward side.

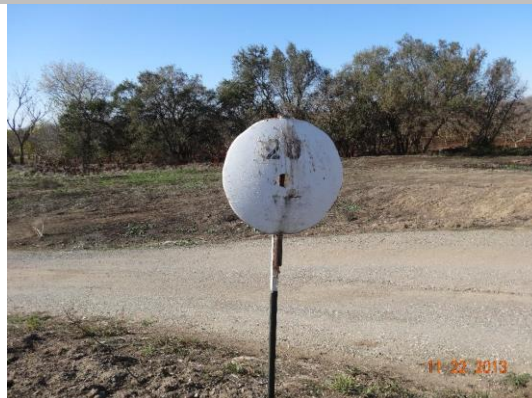
Photo 1 of 3 : UCIP_FA_2019_24769_44454.jpg

Comment Code					
Inspector Comment					
DS_ID:21299 FS_ID:24769 EP_NO: N/A Repair Type: Non-Urgent Crossing Status: Found UCIP Comments: 04/30/2013 Need to contact owner. Need to clear debris from concrete distribution box on waterward and remove debris blocking landward side.This crossing is referenced in the USACE Periodic Inspection as item USACE_CESPK_HON2_2013_p_0383. (DWR UCIP - O. Magana) FIELD_STRUCT_DESC: 24-inch corrugated metal gravity drainage pipe through the levee, 12 feet below the crown. Corrugated metal cutoff wall around the pipe at each shoulder. Flap gate on the waterside (WS) end. Slide gate on the landside (LS). Concrete headwall, saddle, and apron on the WS end. Metal marker on the WS shoulder. [Additional Reference(s): DWR Levee Log, 2005. USACE Sacramento O&M Manual 151, May 1953, (Station 582+72)]. FS Date: 4/30/2013

Marker visible on waterward side shoulder, crossing is referenced as No. 20.

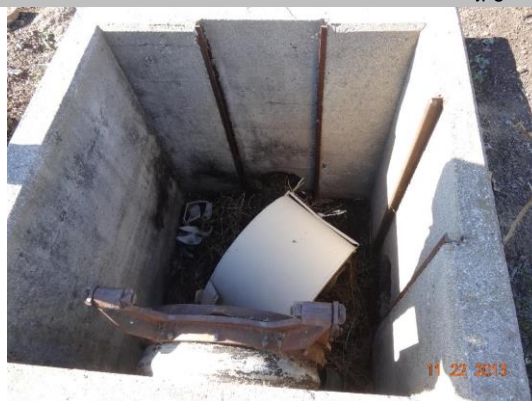
Photo 3 of 3 : UCIP_FA_2019_24769_44452.jpg

Comment Code						
Inspector Comment						
DS_ID:21299 FS_ID:24769 EP_NO: N/A Repair Type: Non-Urgent Crossing Status: Found UCIP Comments: 04/30/2013 Need to contact owner. Need to clear debris from concrete distribution box on waterward and remove debris blocking landward side.This crossing is referenced in the USACE Periodic Inspection as item USACE_CESPK_HON2_2013_p_0383. (DWR UCIP - O. Magana) FIELD_STRUCT_DESC: 24-inch corrugated metal gravity drainage pipe through the levee, 12 feet below the crown. Corrugated metal cutoff wall around the pipe at each shoulder. Flap gate on the waterside (WS) end. Slide gate on the landside (LS). Concrete headwall, saddle, and apron on the WS end. Metal marker on the WS shoulder. [Additional Reference(s): DWR Levee Log, 2005. USACE Sacramento O&M Manual 151, May 1953, (Station 582+72)]. FS Date: 4/30/2013

View of concrete distribution box located on waterward side.

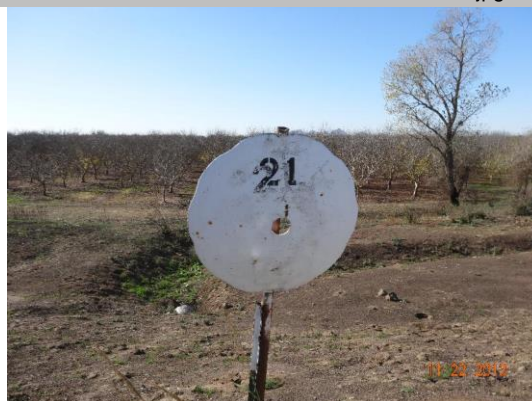
Photo 1 of 3 : UCIP_FA_2019_24835_44721.jpg

Comment Code						
Inspector Comment						
DS_ID:21300						
FS_ID:24835						
EP_NO: N/A						
Repair Type: No Action Needed						
Crossing Status: Found						
UCIP Comments: 04/30/2013 This crossing is referenced in the						
USACE Periodic Inspection as item						
USACE_CESPK_HON2_2013_p_0388. (DWR UCIP - O. Magana)						
FIELD_STRUCT_DESC: 24-inch corrugated metal gravity drainage pipe						
through the levee, 14 feet below the crown. Corrugated metal cutoff wall						
around the pipe at each shoulder. Flap gate on the waterside (WS) end.						
Slide gate on the landside (LS). Concrete headwall, saddle, and apron						
on the WS end. Metal marker on the WS shoulder. [Additional						
Reference(s): DWR Levee Log, 2005. USACE Sacramento O&M						
Manual 151, May 1953, (Station 591+77)].						
FS Date: 4/30/2013

Marker visible on waterward shoulder, crossing referenced as No. 21.

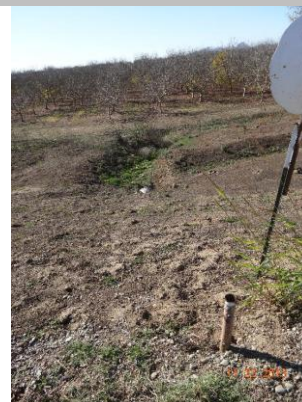
Photo 2 of 3 : UCIP_FA_2019_24835_44720.jpg

View of waterward side.

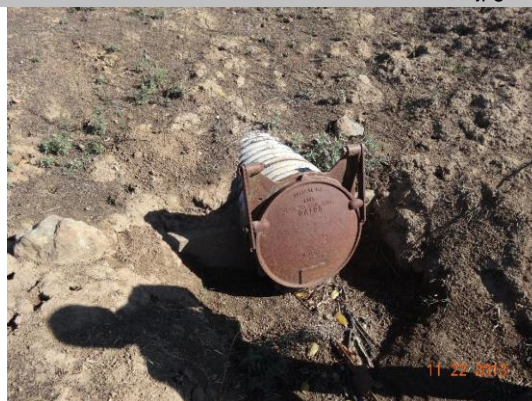
Photo 3 of 3 : UCIP_FA_2019_24835_44725.jpg

Comment Code						
Inspector Comment						
DS_ID:21300						
FS_ID:24835						
EP_NO: N/A						
Repair Type: No Action Needed						
Crossing Status: Found						
UCIP Comments: 04/30/2013 This crossing is referenced in the						
USACE Periodic Inspection as item						
USACE_CESPK_HON2_2013_p_0388. (DWR UCIP - O. Magana)						
FIELD_STRUCT_DESC: 24-inch corrugated metal gravity drainage pipe						
through the levee, 14 feet below the crown. Corrugated metal cutoff wall						
around the pipe at each shoulder. Flap gate on the waterside (WS) end.						
Slide gate on the landside (LS). Concrete headwall, saddle, and apron						
on the WS end. Metal marker on the WS shoulder. [Additional						
Reference(s): DWR Levee Log, 2005. USACE Sacramento O&M						
Manual 151, May 1953, (Station 591+77)].						
FS Date: 4/30/2013

View of flap gate located on waterward side.

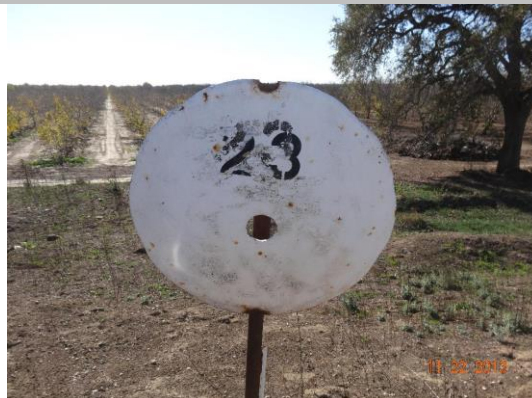
Photo 1 of 3 : UCIP_FA_2019_24837_44731.jpg

Comment Code						
Inspector Comment						
DS_ID:21302						
FS_ID:24837						
EP_NO: N/A						
Repair Type: No Action Needed						
Crossing Status: Found						
UCIP Comments: 04/30/2013 This crossing is referenced in the						
USACE Periodic Inspection as item						
USACE_CESPK_HON2_2013_p_0418. (DWR UCIP - O. Magana)						
FIELD_STRUCT_DESC: 24-inch corrugated metal gravity drainage pipe						
through the levee, 13 feet below the crown. Corrugated metal cutoff wall						
around the pipe at each shoulder. Flap gate on the waterside (WS) end.						
Concrete headwall and 6-foot by 6-foot splash apron at the WS toe. 5-						
foot by 5-foot distribution box at the landside (LS) toe. [Additional						
Reference(s): DWR Levee Log, 2005. USACE Sacramento O&M						
Manual 151, May 1953, (Station 602+47)].						
FS Date: 4/30/2013

Marker visible on waterward shoulder, crossing is referenced as No. 23.

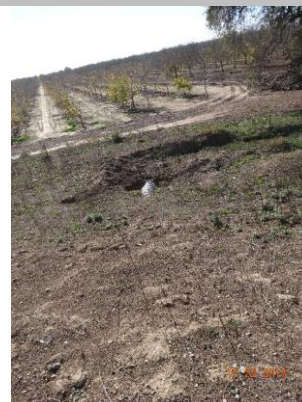
Photo 2 of 3 : UCIP_FA_2019_24837_44735.jpg

Overview of waterward side.

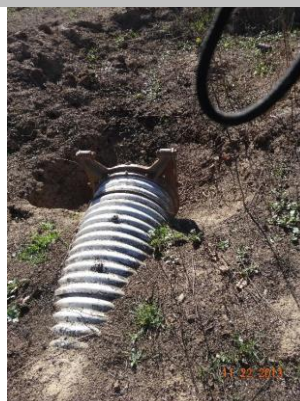
Photo 3 of 3 : UCIP_FA_2019_24837_44734.jpg

Comment Code						
Inspector Comment						
DS_ID:21302						
FS_ID:24837						
EP_NO: N/A						
Repair Type: No Action Needed						
Crossing Status: Found						
UCIP Comments: 04/30/2013 This crossing is referenced in the						
USACE Periodic Inspection as item						
USACE_CESPK_HON2_2013_p_0418. (DWR UCIP - O. Magana)						
FIELD_STRUCT_DESC: 24-inch corrugated metal gravity drainage pipe						
through the levee, 13 feet below the crown. Corrugated metal cutoff wall						
around the pipe at each shoulder. Flap gate on the waterside (WS) end.						
Concrete headwall and 6-foot by 6-foot splash apron at the WS toe. 5-						
foot by 5-foot distribution box at the landside (LS) toe. [Additional						
Reference(s): DWR Levee Log, 2005. USACE Sacramento O&M						
Manual 151, May 1953, (Station 602+47)].						
FS Date: 4/30/2013

Pipe through waterside side.

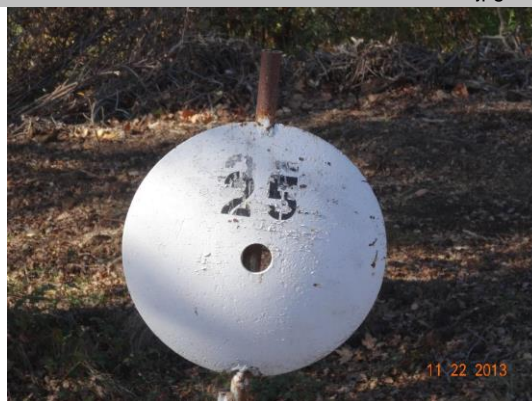
Photo 1 of 3 : UCIP_FA_2019_24840_44753.jpg

Comment Code						
Inspector Comment						
DS_ID:21305 FS_ID:24840 EP_NO: N/A Repair Type: Non-Urgent Crossing Status: Found UCIP Comments: 04/30/2013 Burrow activity--large holes found on landward side. Crossing on landward side is blocked. Recommend clearing headwall and crossing. Need to coordinate with owner to determine status of crossing. If crossing is no longer in use owner will need to contact the CVFPB to comply with Title 23. This crossing is referenced in the USACE Periodic Inspection as item USACE_CESPK_HON2_2013_p_0476. (DWR UCIP - O. Magana) FIELD_STRUCT_DESC: 24-inch corrugated metal gravity drainage pipe through the levee, 7.5 feet below the crown. Corrugated metal cutoff wall around the pipe at each shoulder. Flap gate on the waterside (WS) end. Concrete headwall at each toe. Saddle and apron on the WS. [Additional Reference(s): DWR Levee Log, 2005. USACE Sacramento O&M Manual 151, May 1953, (Station 674+73)]. FS Date: 4/30/2013

Marker visible on waterward side, crossing is referenced as No. 25.

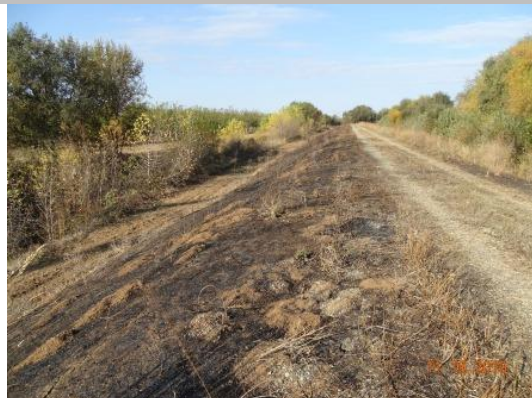
Photo 1 of 1 : FA_2019_RD0010_165_4_20191120_00013.jpg

LM Start	0.50	Rating **	A	Issue No.	4
LM End	2.78	Issue Type +	Ma	Location *	LS
Category	Earthen Levee			GPS Latitude/Longitude	
				Start	End
Item	Vegetation			39.310233 °	39.298646 °
				-121.607111 °	-121.570284 °
DWR ID	DWR_RD0010_03_f_2019_4				
Comment Code					
V1 : Control annual grass and weeds on the levee slopes and easements.					
Inspector Comment					
The annual vegetation is well maintained, Fall 2019.

View looking downstream landside at the well maintained annual vegetation, Fall 2019.

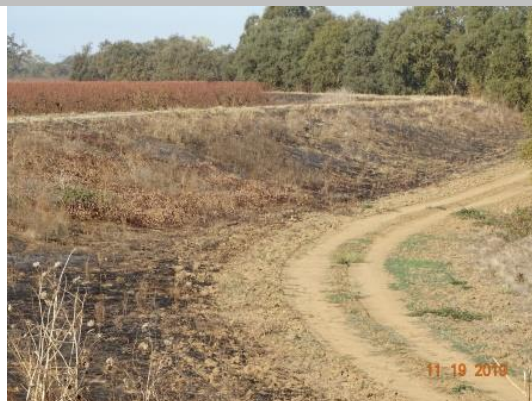
Photo 1 of 1 : FA_2019_RD0010_165_5_20191120_00015.jpg

LM Start	0.50	Rating **	A	Issue No.	5
LM End	2.78	Issue Type +	Ma	Location *	WS
Category	Earthen Levee			GPS Latitude/Longitude	
				Start	End
Item	Vegetation			39.310233 °	39.298646 °
				-121.607111 °	-121.570284 °
DWR ID	DWR_RD0010_03_f_2019_5				
Comment Code					
V1 : Control annual grass and weeds on the levee slopes and easements.					
Inspector Comment					
The annual vegetation is well maintained, Fall 2019.

View looking downstream waterside at the well maintained annual vegetation, Fall 2019.

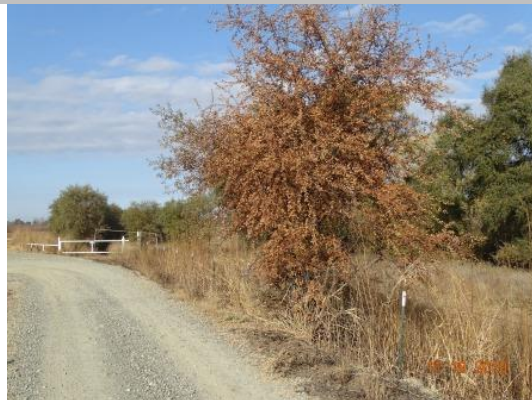
Photo 1 of 1 : FA_2019_RD0010_165_10_20191120_00012.jpg

LM Start	1.10	Rating **	M	Issue No.	10
LM End	1.10	Issue Type +	Ma	Location *	WS
Category	Earthen Levee			GPS Latitude/Longitude	
				Start	End
Item	Trim / Thin Trees			39.306995 °	39.306995 °
				-121.597116 °	-121.597116 °
DWR ID	DWR_RD0010_03_s_2018_10				
Comment Code					
T2 : Thin trees to allow visibility of the ground and room to flood fight.					
Inspector Comment					
Tree needs to be removed for access and visibility, Fall 2019.

View looking downstream waterside of a tree that needs to be trimmed for access and visibility, Fall 2019.

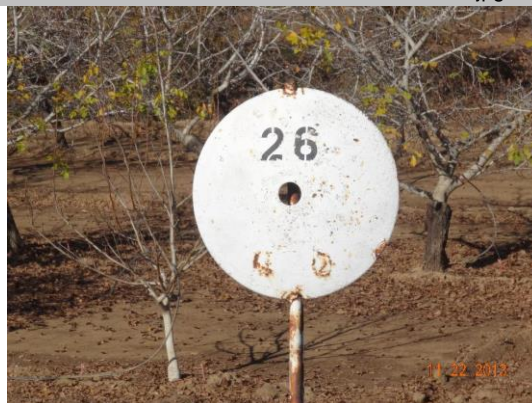
Photo 1 of 3 : UCIP_FA_2019_24842_44764.jpg

Comment Code					
Inspector Comment					
DS_ID:21307					
FS_ID:24842					
EP_NO: N/A					
Repair Type: Non-Urgent					
Crossing Status: Found					
UCIP Comments: 05/01/2013 Sediment deposit inside pipe--Need to coordinate with owner to determine status of crossing. If crossing is no longer in use owner will need to contact the CVFPB to comply with Title 23. (DWR UCIP - O. Magana)					
FIELD_STRUCT_DESC: 24-inch corrugated metal gravity drainage pipe through the levee, 15 feet below the crown. Corrugated metal cutoff wall around the pipe at each shoulder. Flap gate on the waterside (WS) end. Slide gate on the landside (LS) end. Concrete headwall at each toe.					
[Additional Reference(s): DWR Levee Log, 2005. USACE Sacramento O&M Manual 151, May 1953, (Station 134+06)].					
FS Date: 5/1/2013

Marker visible on waterward side--No. 26.

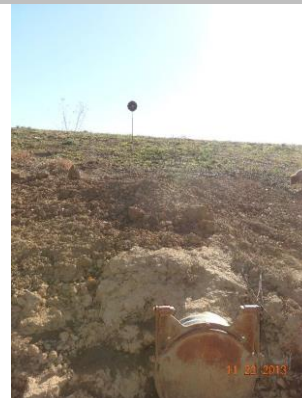
Photo 2 of 3 : UCIP_FA_2019_24842_44762.jpg

Comment Code						
Inspector Comment						
DS_ID:21307						
FS_ID:24842						
EP_NO: N/A						
Repair Type: Non-Urgent						
Crossing Status: Found						
UCIP Comments: 05/01/2013 Sediment deposit inside pipe--Need to coordinate with owner to determine status of crossing. If crossing is no longer in use owner will need to contact the CVFPB to comply with Title 23. (DWR UCIP - O. Magana)						
FIELD_STRUCT_DESC: 24-inch corrugated metal gravity drainage pipe through the levee, 15 feet below the crown. Corrugated metal cutoff wall around the pipe at each shoulder. Flap gate on the waterside (WS) end. Slide gate on the landside (LS) end. Concrete headwall at each toe.						
[Additional Reference(s): DWR Levee Log, 2005. USACE Sacramento O&M Manual 151, May 1953, (Station 134+06)].						
FS Date: 5/1/2013

View of waterward slope.

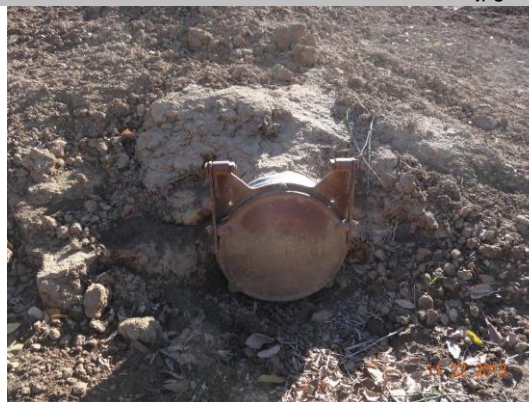
Photo 3 of 3 : UCIP_FA_2019_24842_44763.jpg

View of flap gate located on waterward side.

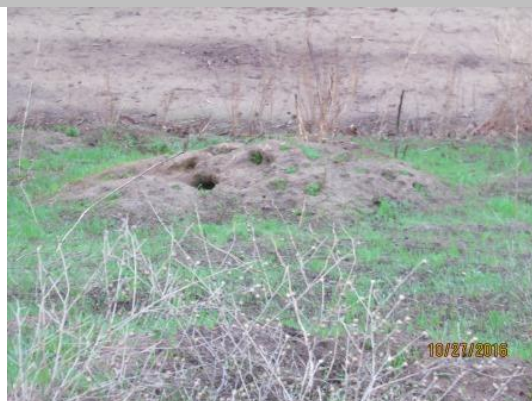
Photo 1 of 1 : FA_2019_RD0010_165_6_20190904_00001.jpg

LM Start	1.72	Rating **	M	Issue No.	6
LM End	1.72	Issue Type +	Ma	Location *	WS
Category	Earthen Levee			GPS Latitude/Longitude	
				Start	End
Item	Animal Control			39.303262 °	39.303262 °
				-121.587680 °	-121.587680 °
DWR ID	DWR_RD0010_03_f_2016_6				
Comment Code					
A3 : No rodents visible, but rodent burrows visible; need to backfill and compact or grout burrows.					
Inspector Comment					
No squirrel activity seen, but rodent holes need to be back filled properly, Fall 2019.

View of waterside slope, no squirrel activity seen, but rodent holes need to be back filled properly.

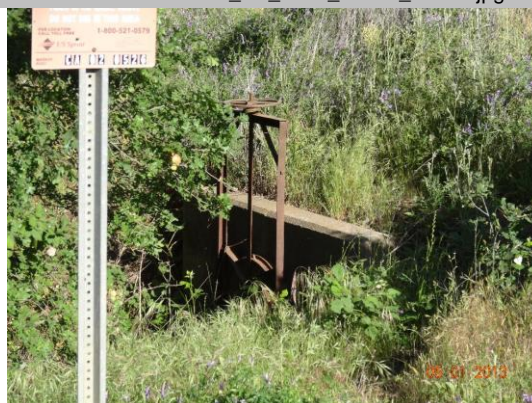
Photo 1 of 2 : UCIP_FA_2019_24883_44820.jpg

LM Start	2.80	Rating **	M	Issue No.	13
LM End	2.80	Issue Type +	Ma	Location *	
Category	Supplemental			GPS Latitude/Longitude	
				Start	End
Item	DRAFT DWR UCIP LMA Responsibility			39.298561 °	39.298561 °
				-121.569977 °	-121.569977 °
DWR ID	21308

Comment Code					
Inspector Comment					
DS_ID:21308 FS_ID:24883 EP_NO: N/A Repair Type: Non-Urgent Crossing Status: Found UCIP Comments: 05/01/2013 Dense vegetation limits the inspector's visibility to identify signs of pipe failure (leaks) along the slope. Recommend removing vegetation along pipe alignment to conduct proper inspection of structure and appurtances. (DWR UCIP - O. Magana) FIELD_STRUCT_DESC: 24-inch corrugated metal gravity drainage pipe through the levee, 12 feet below the crown. Corrugated metal cutoff wall around the pipe at each shoulder. Flap gate on the waterside (WS) end. Slide gate on the landside (LS) end. Concrete headwall at the LS toe. [Additional Reference(s): DWR Levee Log, 2005. USACE Sacramento O&M Manual 151, May 1953, (Station 192+33)]. FS Date: 5/1/2013

View of slide gate and concrete headwall located on landside.
